**Flood Control Project Maintenance
Levee Inspections**
LMA District Cover Sheet
Spring 2014 Levee Inspection Results

San Joaquin County Flood Control and Water Conservation District

Spring 2014 Levee Inspection Results

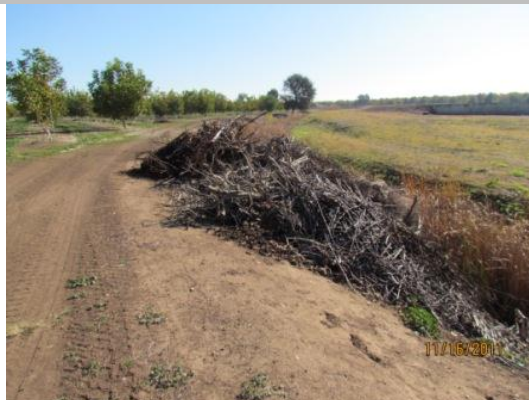
Photo 1 of 1 : pkazi_s_20140415_634.jpg

LM Start	0.25	Rating **	M	Issue No.	5
LM End	0.25	Issue Type +	Ma	Location *	WS
Category	Earthen Levee			GPS Latitude/Longitude	
				Start	End
Item	Encroachments			37.958966 °	37.958966 °
				-121.152641 °	-121.152641 °
DWR ID	DWR_NA0017_17_s_2012_5				
Action/Comments					
Prunings

Prunings were found on the waterside of the levee looking upstream.

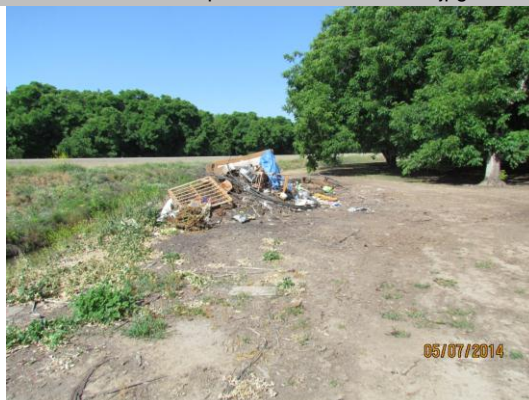
Photo 1 of 1 : pkazi_s_20140512_966.jpg

LM Start	0.36	Rating **	M	Issue No.	6
LM End	0.36	Issue Type +	En	Location *	WS
Category	Earthen Levee			GPS Latitude/Longitude	
				Start	End
Item	Encroachments			37.958883 °	37.958883 °
				-121.154581 °	-121.154581 °
DWR ID	DWR_NA0017_17_s _ 2014_6				
Action/Comments					
Debris

Debris was found on the waterside shoulder of the levee looking downstream.

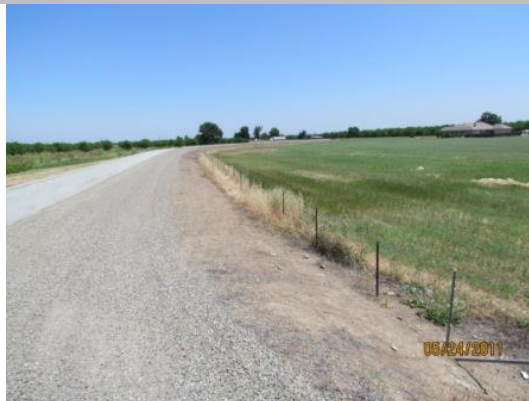
Photo 1 of 1 : pkazi_s_20140415_637.jpg

LM Start	0.08	Rating **	M	Issue No.	1
LM End	0.29	Issue Type +	En	Location *	LS
Category	Earthen Levee			GPS Latitude/Longitude	
				Start	End
Item	Encroachments			37.957534 °	37.958657 °
				-121.149739 °	-121.153146 °
DWR ID	DWR_NA0017_18_s_2012_1				
Action/Comments					
Fence

Fences along the landside toe of the levee. The picture was taken from the crown looking upstream.

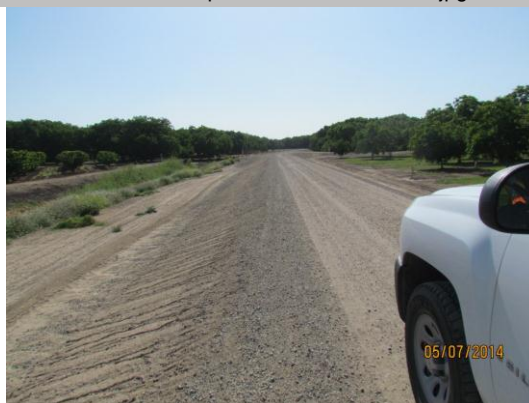
Photo 1 of 1 : pkazi_s_20140512_965.jpg

LM Start	0.62	Rating **	A	Issue No.	3
LM End	0.62	Issue Type +	Ma	Location *	WS
Category	Earthen Levee			GPS Latitude/Longitude	
				Start	End
Item	Vegetation			37.959361 °	37.959361 °
				-121.159000 °	-121.159000 °
DWR ID	DWR_NA0017_18_s_2014_3				
Action/Comments					
Control annual grass and weeds on the levee slopes and easements.

View of the waterside slope of the levee looking upstream.
